DEPARTMENT OF TRANSPORTATION**DIVISION OF ENGINEERING SERVICES**

Contract #: 04-0120F4Cty: SF/ALA Rte: 80 PM: 13.2/13.9File #: 69.28**WELDING INSPECTION REPORT****Resident Engineer:** Pursell, Gary**Address:** 333 Burma Road**City:** Oakland, CA 94607**Report No:** WIR-000602**Date Inspected:** 09-Oct-2007**Project Name:** SAS Superstructure**OSM Arrival Time:** 1300**Prime Contractor:** American Bridge/Fluor Enterprises, a JV**OSM Departure Time:** 2330**Contractor:** Zhenhua Port Machinery Company, Ltd (ZPMC), Changxing Island **Location:** Shanghai, China

CWI Name:	Fu Guo Gang	CWI Present:	Yes	No
Inspected CWI report:	Yes No N/A	Rod Oven in Use:	Yes No N/A	
Electrode to specification:	Yes No N/A	Weld Procedures Followed:	Yes No N/A	
Qualified Welders:	Yes No N/A	Verified Joint Fit-up:	Yes No N/A	
Approved Drawings:	Yes No N/A	Approved WPS:	Yes No N/A	
		Delayed / Cancelled:	Yes No N/A	
Bridge No:	34-0006	Component:	77 & 89 Meter Mock-Up

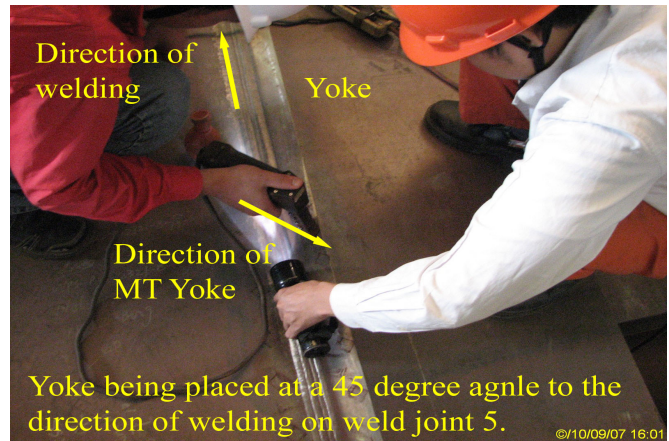
This QA Inspector observed ZPMC Magnetic Particle Testing (MT) Technician, Cai Xinxin testing the cover welds on the 89 Meter Mock-Up, MA24 Skin Plate Sub-Assembly (Face B), partial penetration weld joints 5 & 6 joining MA24-1 to mp505-1. It was noted during the testing that Mr. Cai was placing his MT yoke at 45 degree angles to the direction of welding instead of the conventional zero/ninety degrees. Mr. Cai accepted both weld faces and the four pad eye removal sites on both faces A & B. 10% QA verification MT was conducted, for details see TL-6028 dated October 9, 2007.
